Final FD Report

RP7 Price Control Engineering Support & Asset Management Advice

Utility Regulator for Northern Ireland

16 October 2024

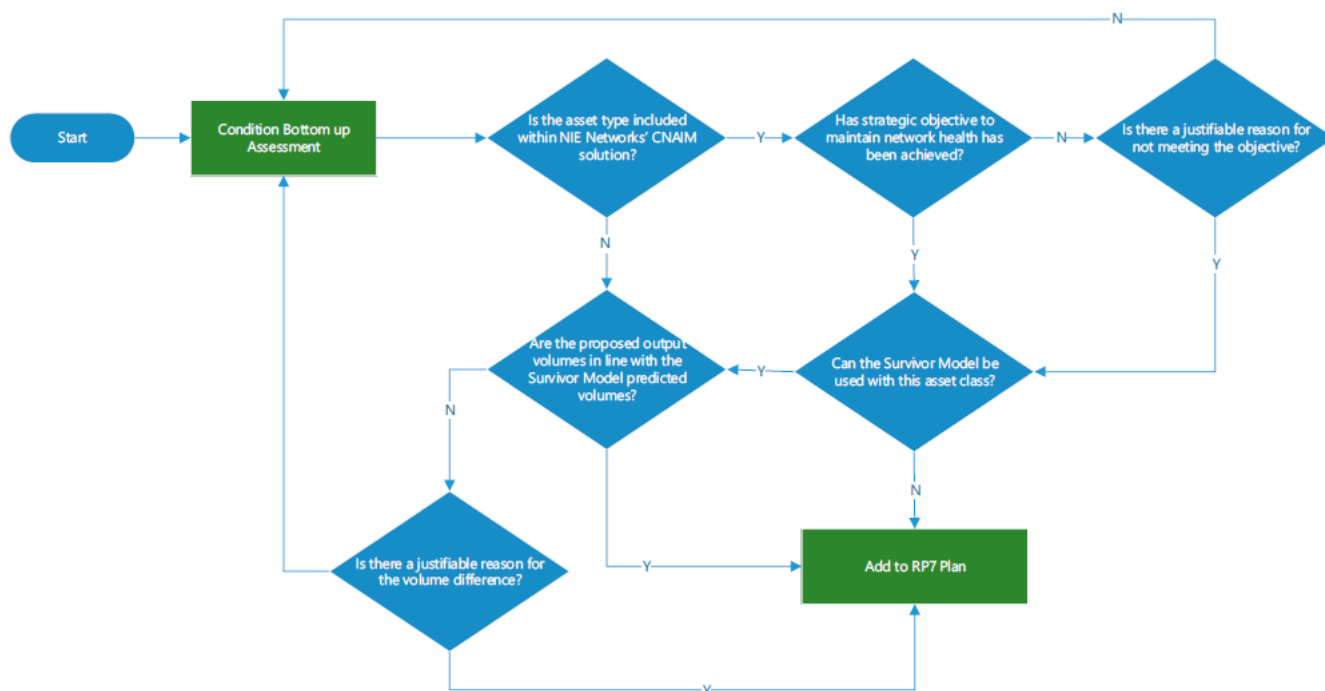
Figure 1 NIE Networks: condition driven investment process chart

Figure 37 of the Business Plan (Page 126) summarised the NIE Networks triangulated approach - presented in Figure 1 below:

In most cases, NIE Networks has used its own condition-based models as the main driver for justifying its RP7 investment plans. Where possible, NIE Networks has benchmarked its identified RP7 volumes relative to both the Common Network Asset Indices Methodology (CNAIM) and the Survivor Age Based Replacement modelling and assessment.

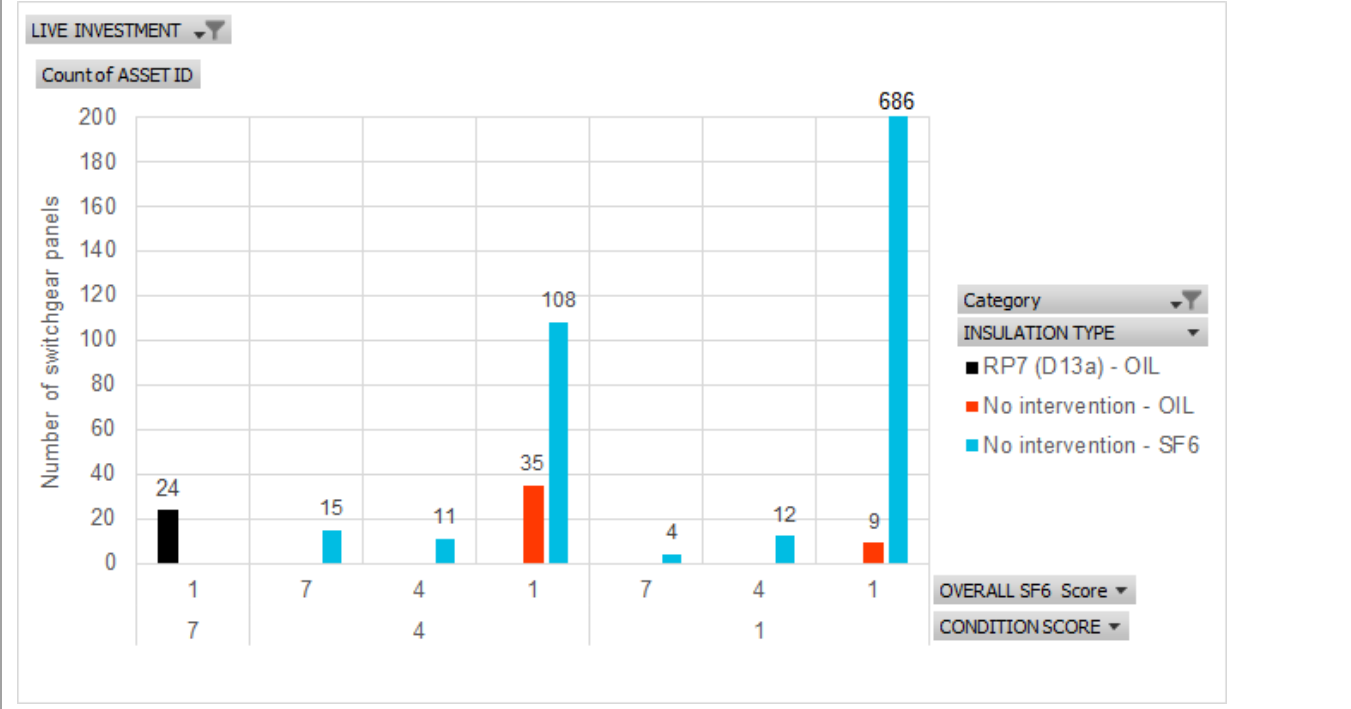
The figure below shows a summary of the planned volumes for intervention in RP7 and volumes of switchboards that have not been subject to any interventions in RP6. The x-axis shows the condition score at the bottom (outer group) and the overall SF6 score above (inner group).

- 35 oil insulated switchboards with average condition (score of 4) are not included in the proposed interventions. 5 of these are Reyrolle L42T type switchboards (subject to type defect highlighted above in relation to the switchboards proposed for replacement).
- 134 SF6 insulated switchboards with average condition are not included in the proposed interventions, of which 15 have a poor SF6 assessment (score of 7) and 11 have an average SF6 assessment (score of 4).
- 9 oil filled switchboards with good condition (score of 1) and 702 SF6 insulated switchboards with good condition have also been excluded from the proposed interventions, of which 4 of the SF6 insulated switchgear have a poor SF6 assessment.

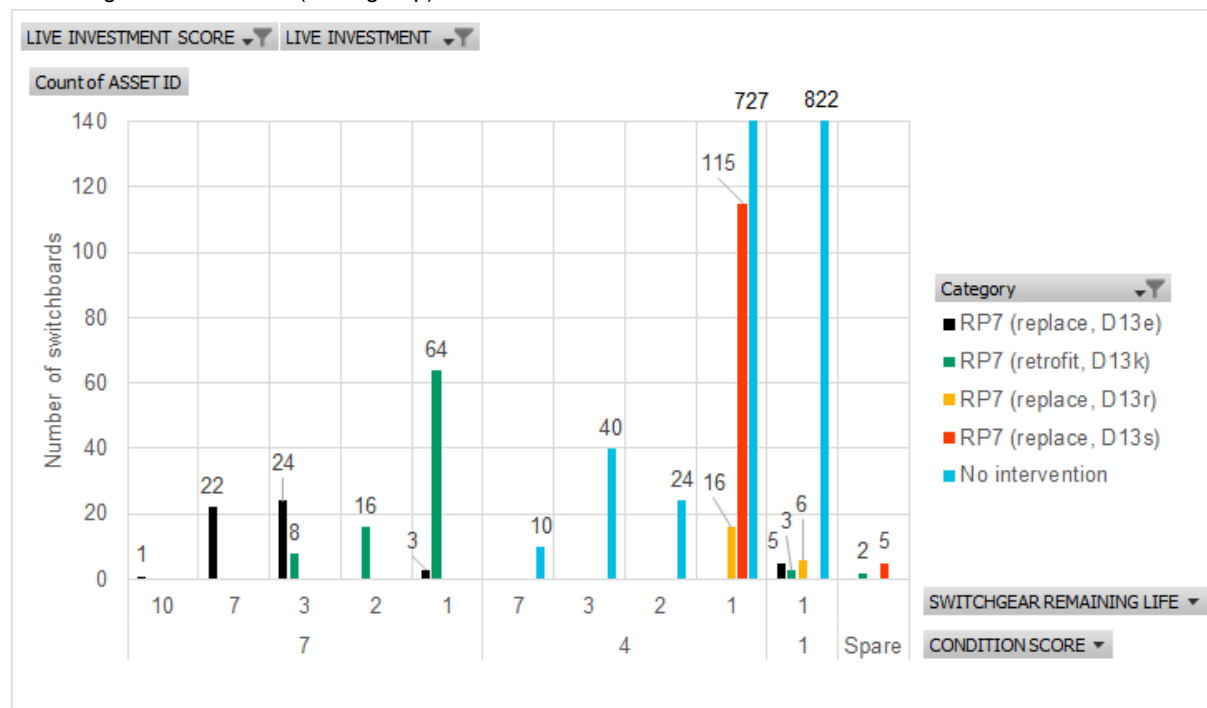
The figure below shows a summary of the planned volumes for intervention in RP7 and volumes of switchboards that have not been subject to any interventions in RP6. The x-axis shows the condition score at the bottom (outer group) and the remaining life score above (inner group).

Element	Description
Characteristics of assets excluded from intervention	<ul style="list-style-type: none"> – 801 average condition switchgear panels (score of 4) have been excluded from the proposed interventions. – 822 good condition switchgear panels (score of 1) have been excluded from the proposed interventions.
Conclusion	Based on our review of the condition assessment model, we conclude that the stated volumes for RP7 interventions in the D13e, k, r and s expenditure categories are reasonable and we recommend allowance of these volumes for RP7 period.

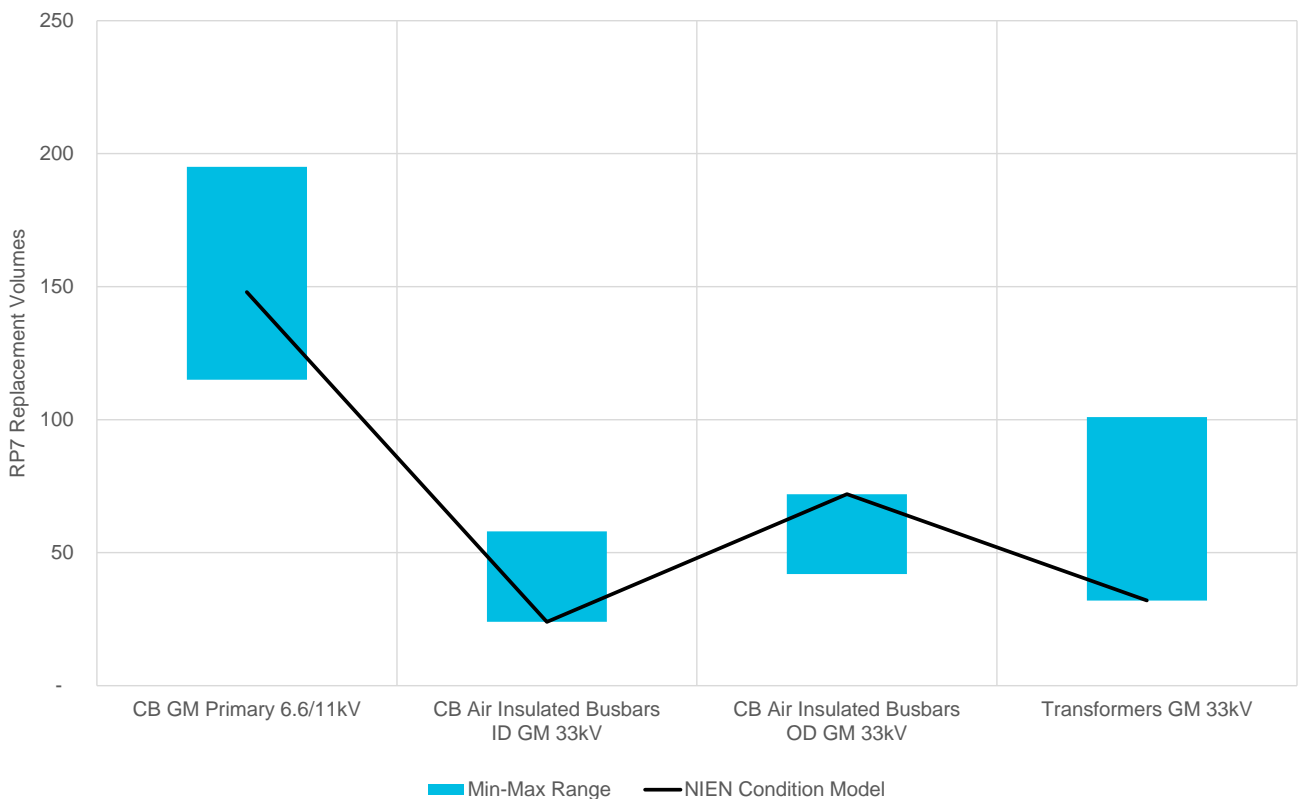
Figure 2 Comparison of Model Outputs - 33 kV Replacement Volumes

In order to further verify the proposed RP7 replacement volumes, we also carried out a review of NIE Networks' replacement volumes from each of their modelling scenarios (described previously in Section 2.1.4). Figure 2 below shows the max-min range of the model outputs, in terms of RP7 for each of the three methodologies, with the NIE Networks condition-based model output also represented. It is evident that with the exception of the 33 kV Outdoor CB asset category, the proposed replacement volumes are within range or the lowest of the model outputs.

For the 33 kV Outdoor CB replacement volume, the NIE Networks condition-based model produces the highest replacement volumes for RP7. This higher volume is driven by a specific type-defect (SWS EO1 type), described above for which NIE Networks has investigated repair options for the oil filled 33 kV circuit breaker but with no viable solution being identified. We remain satisfied that the replacement volumes for these asset categories are reasonable for RP7.

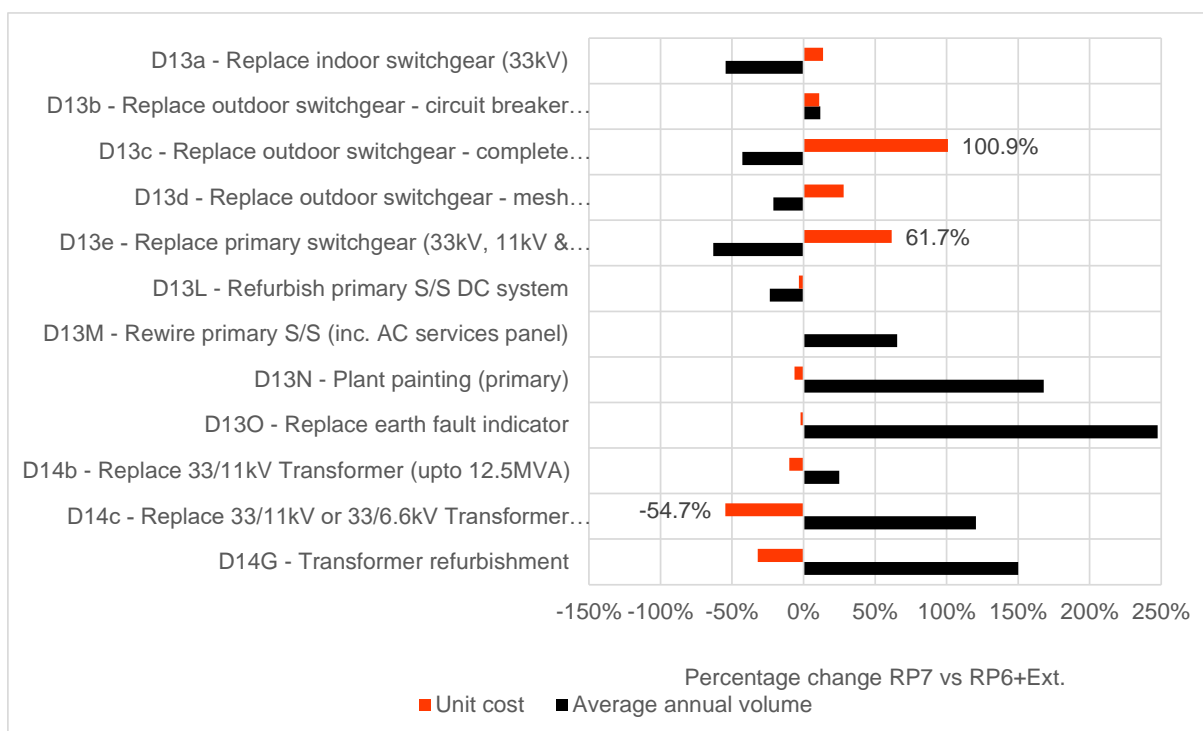
Figure 3 Distribution Primary plant – Unit cost assessment

The percentage changes in the unit cost (RP7 request compared with RP6 outturn to 31-Mar-2023) is presented in Figure 3, along with the equivalent percentage changes in asset volumes.

From Figure 3 it is evident that the requested unit costs for the D13c and D13e expenditure categories correspond to the greatest percentage changes. In addition, NIE Networks’ query response on unit costs¹³ indicates the assessment carried out by NIE Networks to apply adjustments to the March 2022 outturn unit rates. These comprise adjustments to account for:

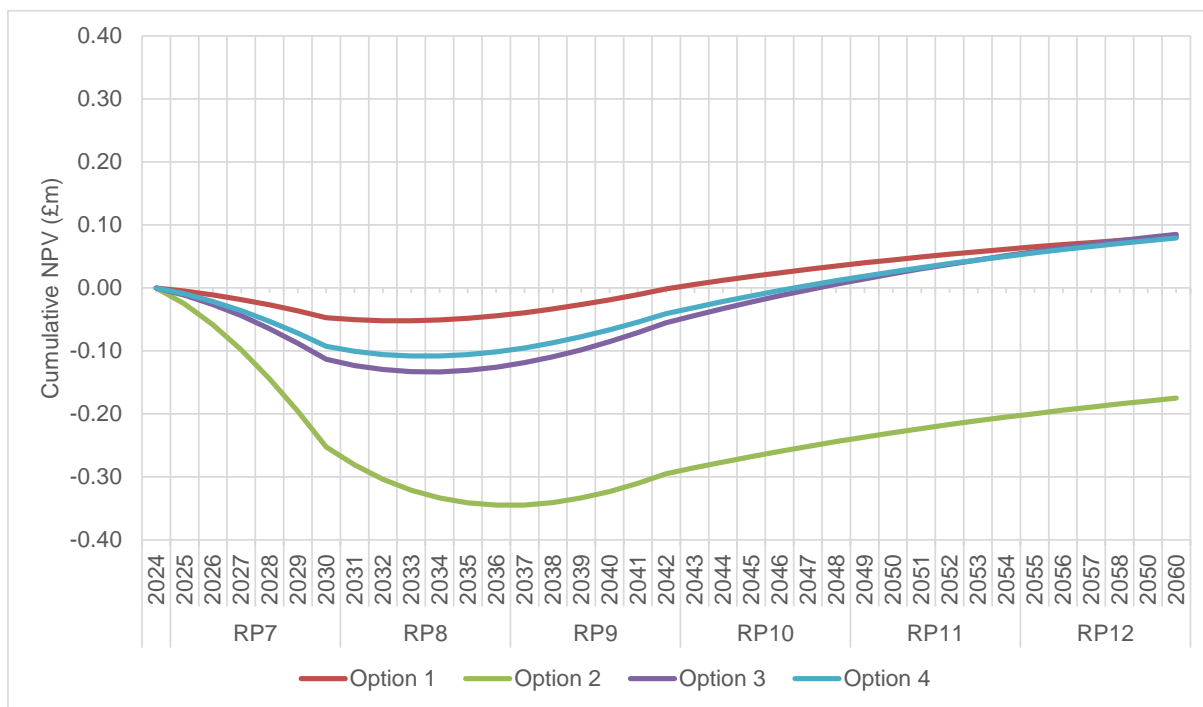
Figure 4 D13o – cumulative NPV of options presented by NIE Networks in its CBA

The CBA includes assumptions about the benefits that may be derived from the installation of EFIs with remote indication, which are made up of avoided costs associated with CB operation and average labour cost savings associated with repair of cable faults. The GHD analysis has not interrogated these stated benefits in detail. However, the analysis appears to have been applied consistently for the four options considered and Figure 4 presents the cumulative NPV of each of the four options, taken from NIE Networks’ analysis.

It can be seen that, based on the modelled costs and benefits, none of the options achieve a positive cumulative NPV until 2042. As presented, the CBA appears to support the approach to minimise up front costs by adopting basic EFIs. However, GHD acknowledges that smart EFIs installed in strategic locations are expected to provide benefits (including ‘reduction in post-fault maintenance and engineering labour time... to achieve efficiency savings against indirect costs from these activities’).

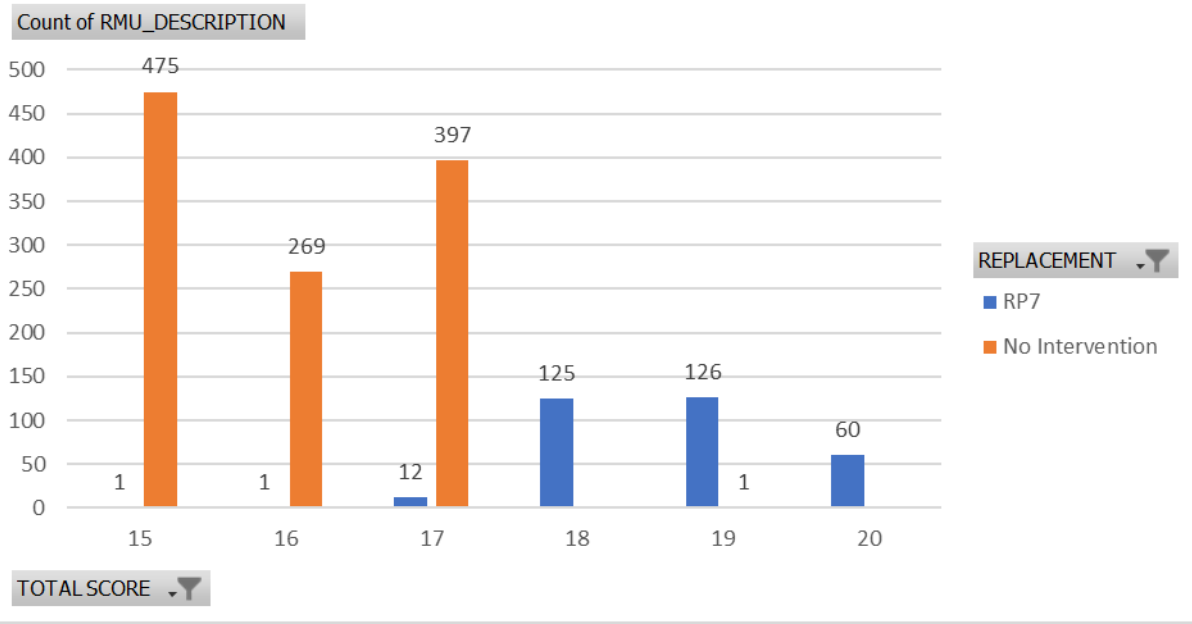
<p>The figure below shows a summary of the planned volumes for complete substation replacement in RP7 and those that would not be subject to any intervention. The x-axis shows the total score, the total scores ranged from 9 to 23, but only those with a score of 15 or higher are shown in the figure below. The RP7 intervention proposed covers replacement of 5.5% of the total population of 11 kV & 6.6 kV ground-mounted secondary substations.</p>

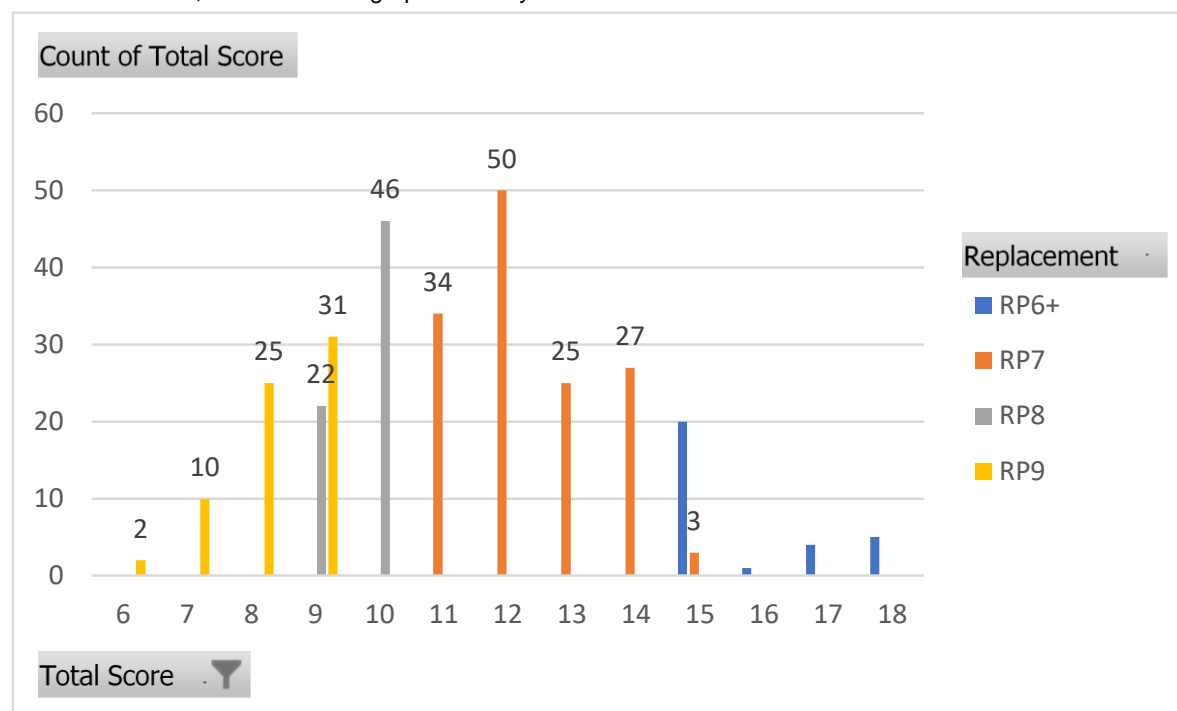
The figure below shows a summary of the planned volumes for intervention in RP7 and asset quantities that NIE Networks has previously identified for RP6 intervention plus those targeted for price control periods beyond RP7. The x-axis shows overall asset score. The graph only shows 305 assets scoring 6 and above. There are a further 150 assets with lower scores, not included in graphical analysis below.

Characteristics of assets excluded from intervention	<ul style="list-style-type: none"> – 68 sectionalisers with an overall score of 9-10 identified for intervention in RP8. – 68 sectionalisers with an overall score in the range 6-9 identified for intervention in RP9. – 150 sectionalisers with an overall score less than 6 are not included in any future planned interventions.
Conclusion	Following our detailed review, we recommend that the stated volumes for RP7 interventions in the D15k expenditure category are included within the RP7 DD allowance.

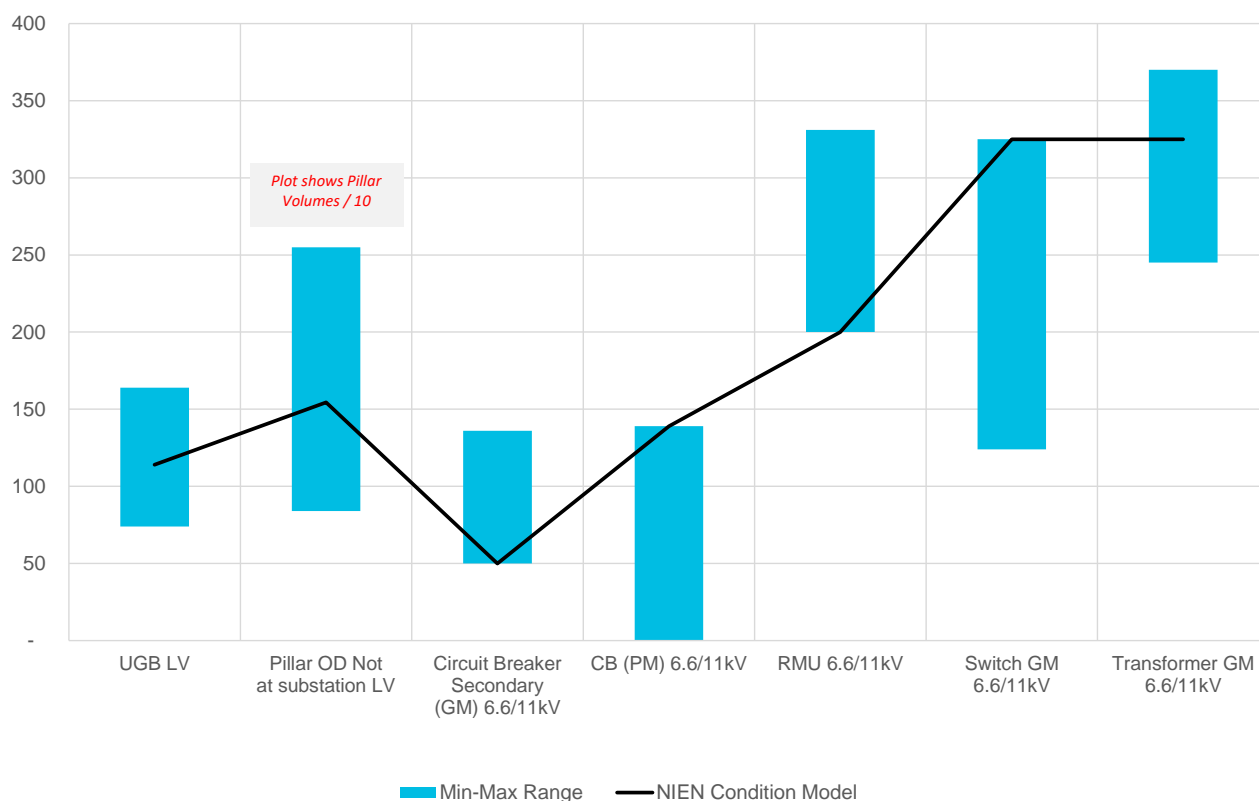
Figure 5 Comparison of Model Outputs - 11 kV & LV Asset Replacement Volumes

In order to further verify the proposed RP7 replacement volumes, we also carried out a review of NIE Networks’ replacement volumes from each of their modelling scenarios (described previously in Section 2.1.4). Due to the sub-programme structure of NIE Networks’ Investment Plan, it is not possible to directly model replacement volumes for all asset types using all three methodologies. Where this is possible, either directly or indirectly (e.g. 11 kV ground-mounted switchgear), we have included the asset type within our further review and Figure 5 below shows the max-min range of the model outputs, in terms of RP7 for each of the three methodologies, with the NIE Networks condition based model output also represented. It is evident that, with the exception of the pole mounted 11 kV switchgear and ground mounted switchgear, the proposed replacement volumes are within range or the lowest of the model outputs.

For the 11 kV ground-mounted switch replacement volumes, the replacement volumes are included within the work programme for complete substation replacement. The prioritisation of these replacement works is based on detailed condition-based assessment for the NIE Networks distribution substation portfolio, which the age-based survivor model would not factor into the calculation of replacement volumes. We remain satisfied that the replacement volumes for these asset categories are reasonable for RP7.

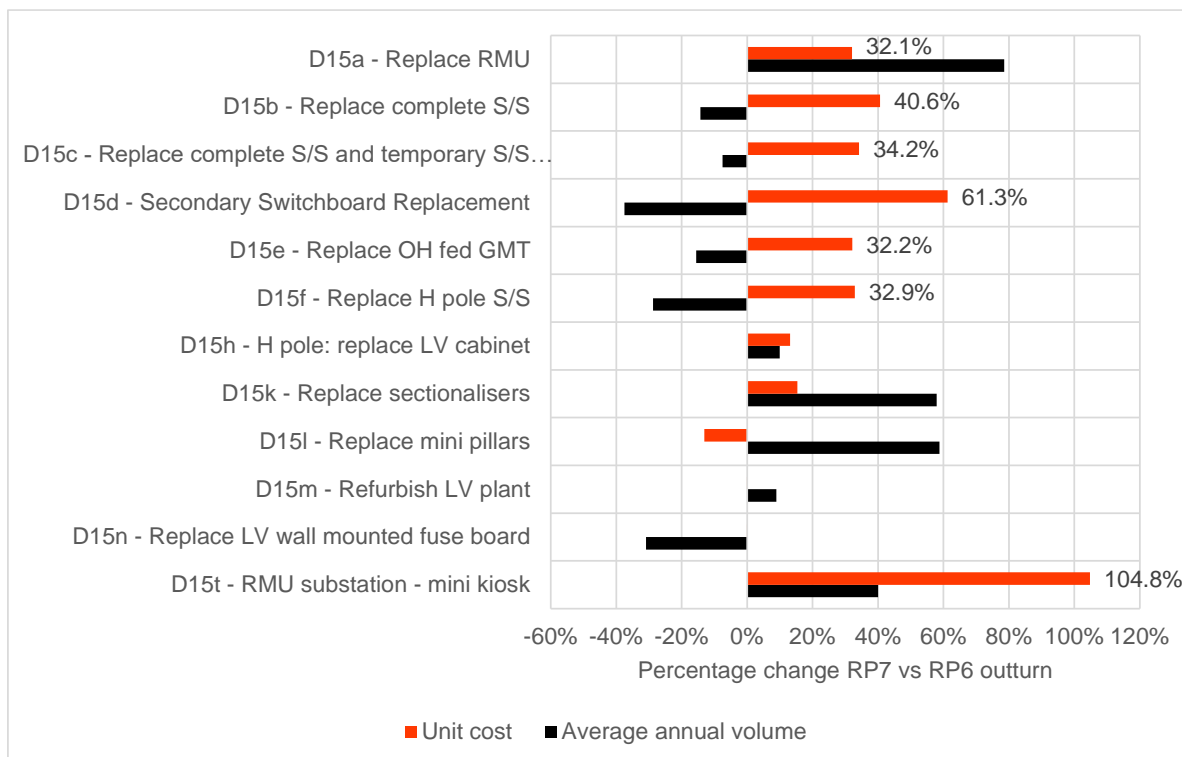
Figure 6 Distribution Secondary plant – Unit cost assessment

The percentage changes in the unit cost (RP7 request compared with RP6 Outturn) is presented in Figure 6, along with the equivalent percentage changes in asset volumes.

From Figure 6, it can be seen that 7 categories observed unit cost increases, when comparing RP6 outturn to RP7 that were greater than 20%, the largest increase being associated with RMU substation mini-kiosk replacements.

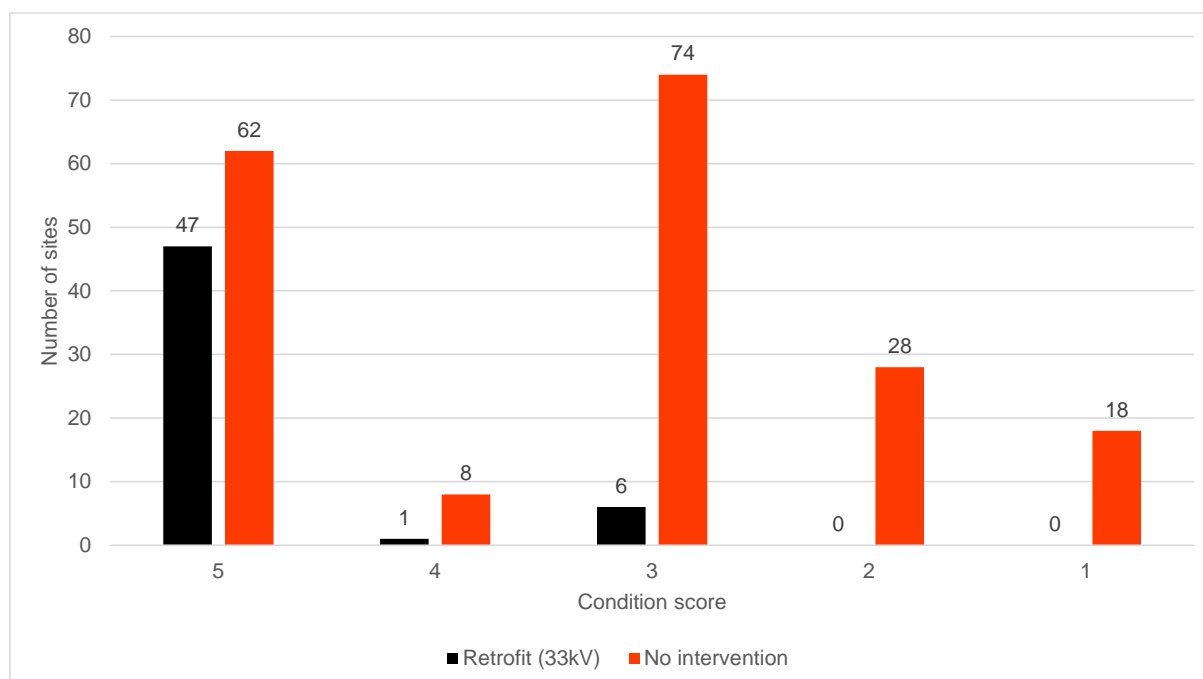
Figure 7 Distribution protection – Condition assessment summary for 33 kV sites (retrofit)

The following figures are taken from the response to query UR-091, which show only sites, but not the number of relays.

The results shown in Figure 7 and Figure 8 indicate a high population of sites where equipment has been assigned a score of 5 (immediate intervention required).
